Determination of radon transmittance

RISE was requested to measure the radon transmittance through a sheet material in accordance with SP Method no. 3873.

The client delivered the material, under the name of HQB2 butyl tape, to RISE Research Institute of Sweden on 2017-02-16. There were no signs of visible damage to the material on arrival. The thickness was 1.5 mm, given by the client. The material was tested without joints. See Appendix 2 for a picture of the material.

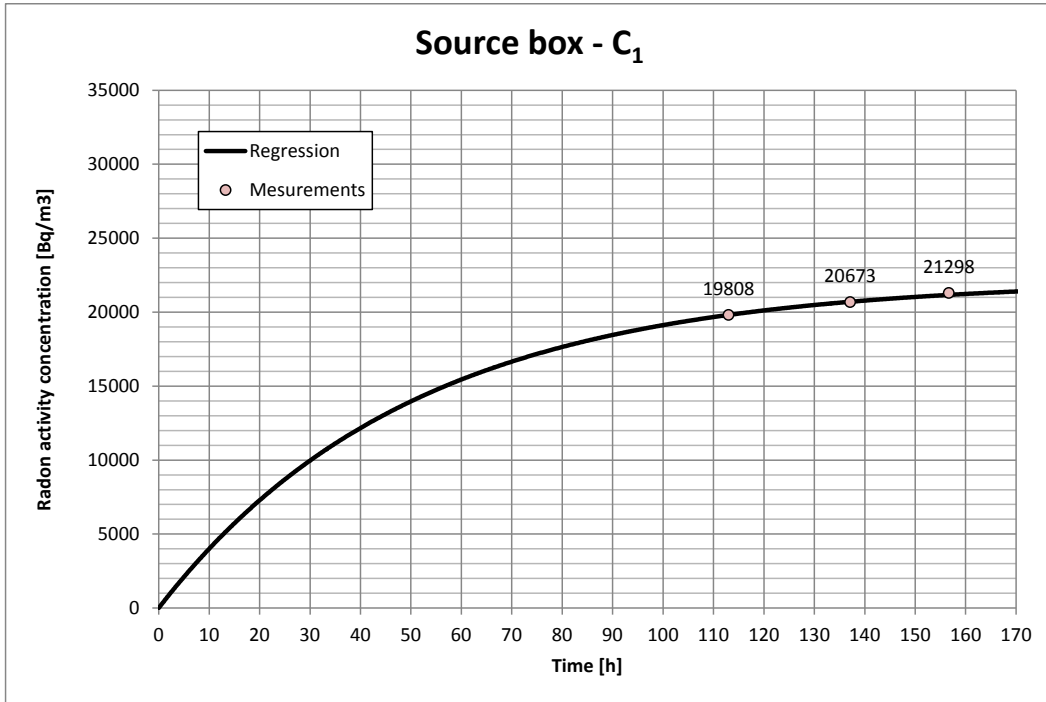
Figure 1 Radon concentration in the primary box: measured daily average values and the regression curve.

box. This difference causes a flow of radon by diffusion through the test material. Only radon gas (Rn) passes through, and not its decay products (RnD). Radon transmittance is measured by measuring the change in radon concentration on both sides of the test material. Figures 1 and 2 show how the radon concentrations build up in the two boxes.

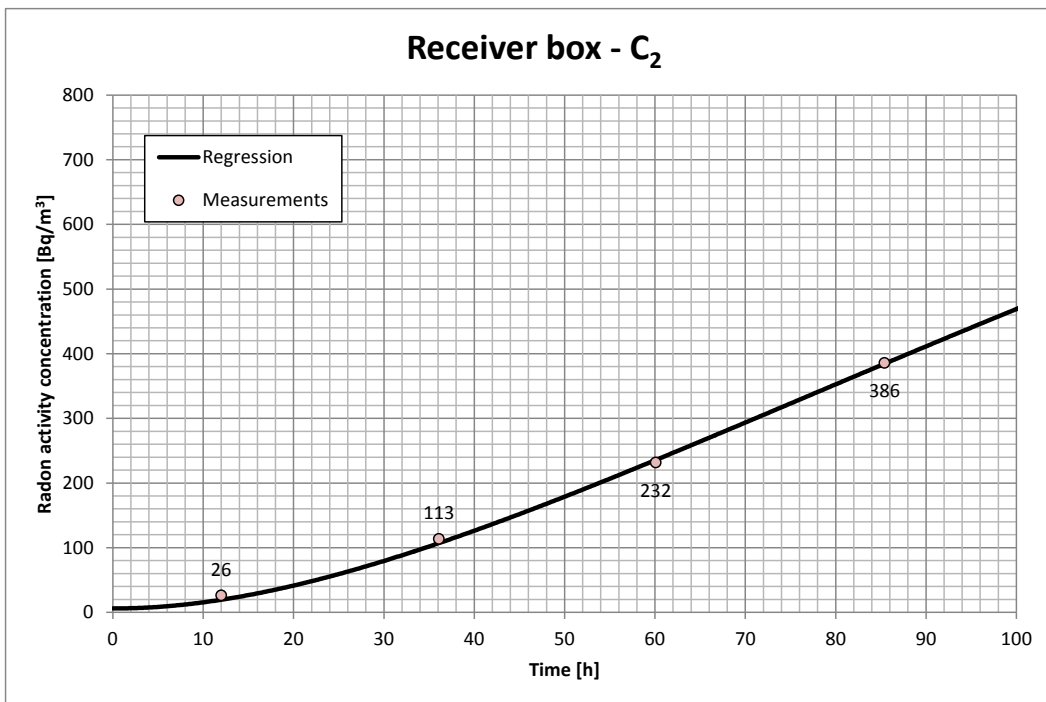
Figure 2 Radon concentration in the secondary box: measured daily average values and the regression curve.

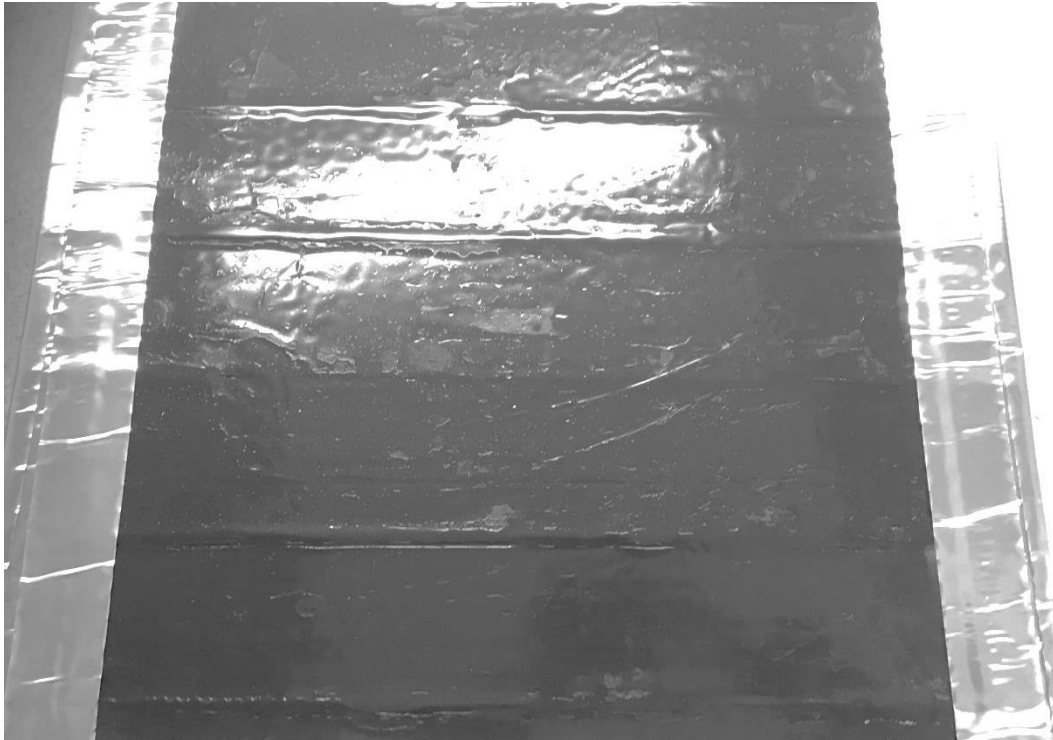
HQB2 butyl tape
